MOLD INSPECTION REPORT

Property Address:

5678 Lemon Street
Mount Prospect, IL
60056

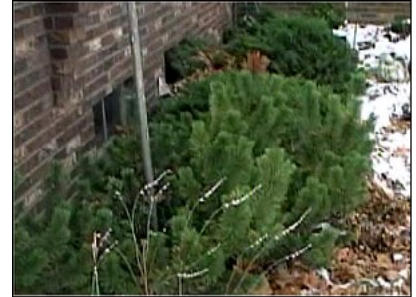
There is vegetation close to the structure. This is a maintenance issue. Vegetation should be kept at least several feet from the house because the roots retain moisture that can keep soil near the siding and foundation perpetually wet where mold can form. Recommend maintenance by an experienced landscaper.

There is soil built-up against the wall. This is a maintenance issue. Soil should be evenly graded along the side of a house. Because it retains moisture, soil should not be close to any siding material. Recommend maintenance by an experienced landscaper or a licensed contractor.

Regular maintenance needed.

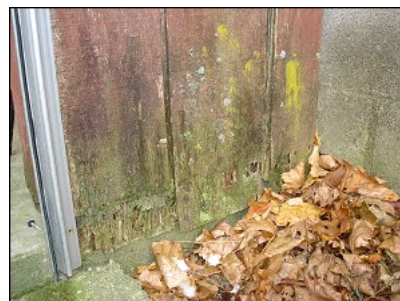
There were signs of microbial growth observed. This is a moderate to serious issue. Suspected microbial growth and its toxicity can only be confirmed by sampling and laboratory testing. Sampling can include tape, swab, air, or bulk methods. The method of remediation depends upon the type of mold. Recommend a mold remediation plan to address clean-up and prevention.

Northwest patio corner. Client accepted sampling.

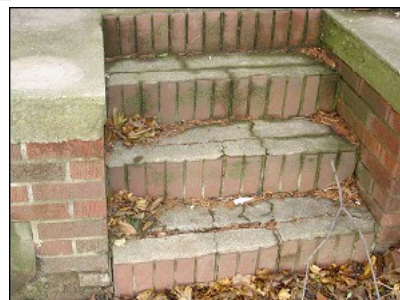
There are cracks/open penetrations observed. This is a maintenance issue. Penetrations that allow water to collect or enter the structure create conditions where mold can grow. Water damage or microbial growth occurring as a result may not be visible at the point of penetration. Recommend maintenance by a licensed contractor.

Deteriorated and sloping.

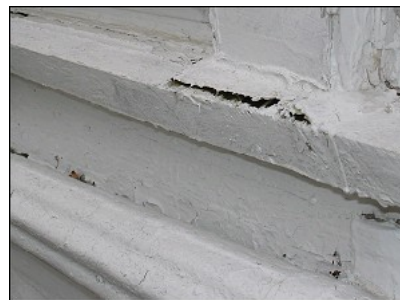
There were signs of water damage observed. This is a moderate to serious issue. Water intrusion into the structure can lead to mold growth and other problems. Removing water-damaged materials for repair or replacement may reveal further damage and microbial growth. Recommend maintenance by a licensed contractor.

There were holes or deflections observed in the wall covering. This is a maintenance issue. Penetrations that allow water to collect or enter the structure create conditions where mold can grow. Water damage or microbial growth occurring as a result may not be visible at the point of penetration. Recommend maintenance by a licensed contractor.

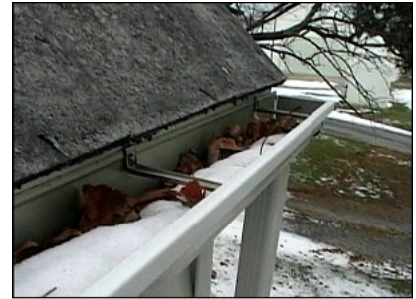
There was a build-up of debris in the gutters. This is a maintenance issue. Partially blocked gutters can allow water to penetrate the siding, and can lead to wet conditions where mold can grow. Recommend regular cleaning and maintenance of gutters.

There are gutters missing. This is a maintenance issue. A lack of gutters allows roof drainage to pool water near the foundation walls and to run down exterior walls. Water that collects at the foundation can eventually penetrate the exterior walls and lead to mold infiltration. Recommend maintenance by a licensed contractor.

East and north sides of structure, and garage.

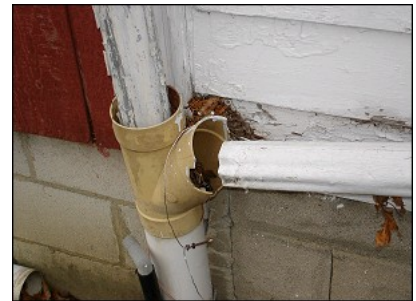
The downspouts appear damaged or deteriorated. This is a maintenance issue. Downspouts direct water from gutters away from the structure, rather than near the foundation walls where water can penetrate the structure and lead to mold infiltration. Recommend maintenance by a licensed contractor.

There are missing downspouts. This is a maintenance issue. Downspouts direct water from gutters away from the structure, rather than near the foundation walls where water can penetrate the structure and lead to mold infiltration. Recommend maintenance by a licensed contractor.

Missing north side of structure, garage, patio.

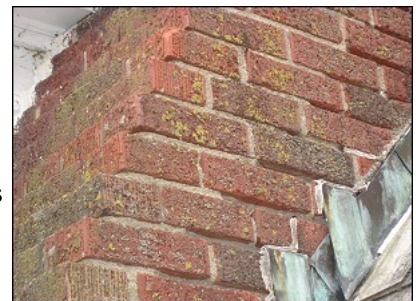
There were signs of microbial growth observed. This is a moderate to serious issue. Suspected microbial growth and its toxicity can only be confirmed by sampling and laboratory testing. Sampling can include tape, swab, air, or bulk methods. The method of remediation depends upon the type of mold. Recommend a mold remediation plan to address clean-up and prevention.

There flashing appears improperly installed. This is a maintenance issue. When installed correctly, flashing prevents water from entering the structure at roof joints and penetrations. Water that travels beneath flashing can saturate the roof sheathing, leading to conditions that allow mold to form and thrive. Recommend maintenance by a licensed contractor.

The flashing appears damaged/deteriorated. This is a maintenance issue. Flashing that no longer functions properly can allow water to enter the structure, possibly leading to conditions that allow mold infiltration.

Flashing is rusted and caulked.

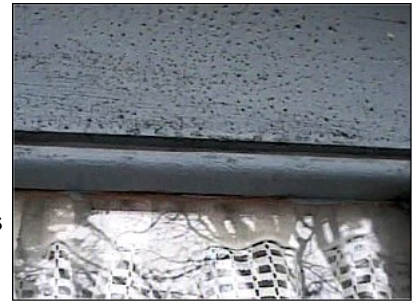
There were signs of water damage observed. This is a moderate to serious issue. Water intrusion into the structure can lead to mold growth and other problems. Removing water-damaged materials for repair or replacement may reveal further damage and microbial growth. Recommend maintenance by a licensed contractor.

There were signs of dry rot. This is a moderate to serious issue. Dry rot is a type of microbial growth that feeds on moisture-rich wood from the inside out. Removing water-damaged materials for repair or replacement may reveal further damage and microbial growth. Recommend maintenance by a licensed contractor.

There were cracks/open penetrations observed. This is a maintenance issue. Penetrations that allow water to collect or enter the structure create conditions where mold can grow. Water damage or microbial growth occurring as a result may not be visible at the point of penetration. Recommend maintenance by a licensed contractor.

South side door panels are exposed. Wood exterior back door appears very old and has been exposed to the elements.

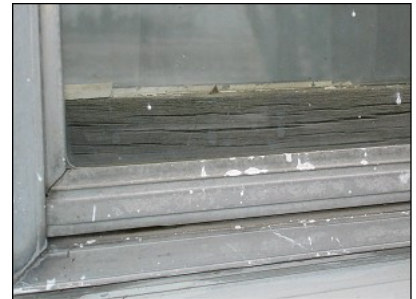
Window 1

There were signs of water damage observed. This is a moderate to serious issue. Water intrusion into the structure can lead to mold growth and other problems. Removing water-damaged materials for repair or replacement may reveal further damage and microbial growth. Recommend maintenance by a licensed contractor.

There were signs of dry rot. This is a moderate to serious issue. Dry rot is a type of microbial growth that feeds on moisture-rich wood from the inside out. Removing water-damaged materials for repair or replacement may reveal further damage and microbial growth. Recommend maintenance by a licensed contractor.

Water can pool on the sill. This is a maintenance issue. Pooling water can penetrate the surface and enter the structure, creating conditions where mold can grow or deteriorate materials. Recommend maintenance by a licensed contractor.

The paint is deteriorated. This is a maintenance issue. If paint is peeling, water can collect behind the paint and create conditions where mold can grow or deteriorate the surface. Recommend maintenance by a licensed contractor.

There were cracks/open penetrations observed. This is a maintenance issue. Penetrations that allow water to collect or enter the structure create conditions where mold can grow. Water damage or microbial growth occurring as a result may not be visible at the point of penetration. Recommend maintenance by a licensed contractor.

The grout/caulking is deteriorated. This is a maintenance issue. Deteriorated or incorrectly applied grout and caulking can allow water to penetrate the structure, resulting in water damage or mold growth. Water damage or microbial growth occurring may be hidden from view. Recommend maintenance by a licensed contractor.

Three windows together on west side of structure.

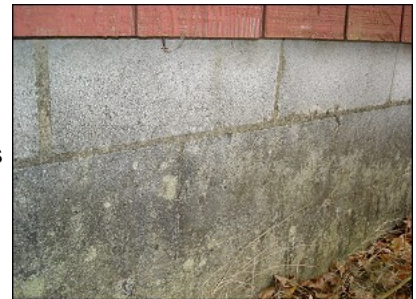
Foundation

There were signs of microbial growth observed. This is a moderate to serious issue. Suspected microbial growth and its toxicity can only be confirmed by sampling and laboratory testing. Sampling can include tape, swab, air, or bulk methods. The method of remediation depends upon the type of mold.

There were cracks/open penetrations observed. This is a maintenance issue.

Mold-like substance on northwest portion. Client declined sampling.

Recommend a mold remediation plan to address clean-up and prevention.

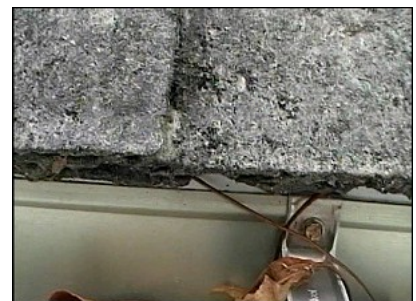
Roof Covering

There were signs of microbial growth observed. This is a moderate to serious issue. Suspected microbial growth and its toxicity can only be confirmed by sampling and laboratory testing. Sampling can include tape, swab, air, or bulk methods. The method of remediation depends upon the type of mold. Recommend a mold remediation plan to address clean-up and prevention.

There were cracks/open penetrations observed. This is a maintenance issue. Penetrations that allow water to collect or enter the structure create conditions where mold can grow. Water damage or microbial growth occurring as a result may not be visible at the point of penetration. Recommend maintenance by a licensed contractor.

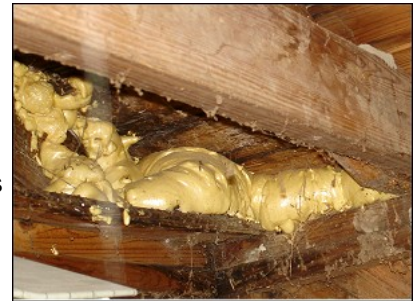
There were signs of microbial growth observed. This is a moderate to serious issue. Suspected microbial growth and its toxicity can only be confirmed by sampling and laboratory testing. Sampling can include tape, swab, air, or bulk methods. The method of remediation depends upon the type of mold. Recommend a mold remediation plan to address clean-up and prevention.

There were signs of water damage observed. This is a moderate to serious issue. Water intrusion into the structure can lead to mold growth and other problems. Removing water-damaged materials for repair or replacement may reveal further damage and microbial growth. Recommend maintenance by a licensed contractor.

There were water stains on the sheathing. This is a maintenance issue. Water stains or efflorescence, a white mineral substance, indicate past water intrusion in this area, which can lead to microbial growth. Recommend maintenance by a licensed contractor.

Cannot tell if there is active leak. There were some areas that could not be inspected due to visual inaccessibility.

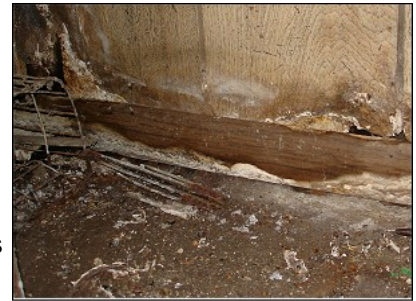
There were signs of microbial growth observed. This is a moderate to serious issue. Suspected microbial growth and its toxicity can only be confirmed by sampling and laboratory testing. Sampling can include tape, swab, air, or bulk methods. The method of remediation depends upon the type of mold. Recommend a mold remediation plan to address clean-up and prevention.

There were signs of water damage observed. This is a moderate to serious issue. Water intrusion into the structure can lead to mold growth and other problems. Removing water-damaged materials for repair or replacement may reveal further damage and microbial growth. Recommend maintenance by a licensed contractor.

There was a musty odor/dampness observed. This is a potential issue to monitor. A musty odor or dampness may indicate past water penetration, insufficient ventilation, or hidden mold. An air sampling test would be required to determine the actual air quality in this area.

There were water stains/efflorescence observed. This is a maintenance issue. Water stains or efflorescence, a white mineral substance, indicate past water intrusion in this area, which can lead to microbial growth. Recommend maintenance by a licensed contractor.

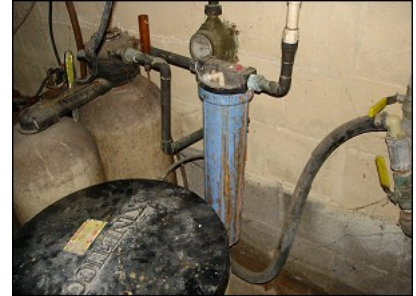
There were water stains observed. This is a maintenance issue. Water stains indicate either past water penetration or water vapor condensation. Either condition can lead to microbial growth. Recommend maintenance by a licensed contractor.

There are signs of corrosion/deterioration. This is a maintenance issue. Corrosion on pipes may indicate a potential water leak that could occur at any time. Water leaks can cause significant damage and create conditions where mold can thrive. Recommend maintenance by a licensed contractor.

Hot water side has the most corrosion.

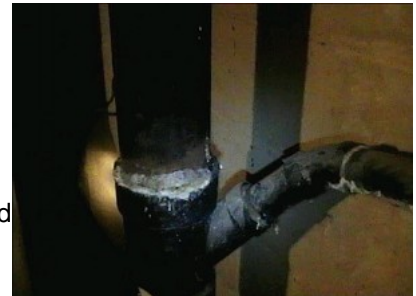
There were water stains observed. This is a maintenance issue. Water stains or efflorescence, a white mineral substance, indicate past water intrusion in this area, which can lead to microbial growth. Recommend maintenance by a licensed contractor.

There are signs of corrosion/deterioration. This is a maintenance issue. Corrosion on pipes may indicate a potential water leak that could occur at any time. Water leaks can cause significant damage and create conditions where mold can thrive. Recommend maintenance by a licensed contractor.

At cast iron pipe connection in basement.

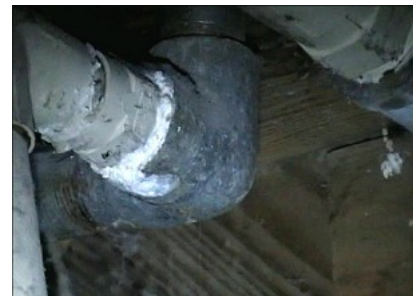
There was corrosion/deterioration present. This is a maintenance issue. Corrosion on pipes may indicate a potential water leak that could occur at any time. Water leaks can cause significant damage and create conditions where mold can thrive. Recommend maintenance by a licensed contractor.

The extension does not terminate at a floor drain. This is a maintenance issue. If the temperature pressure relief valve is activated, water should have a clear path to a floor drain or other location where water cannot accumulate and cause damage. Recommend maintenance by a licensed contractor.

Hot water side has the most corrosion.

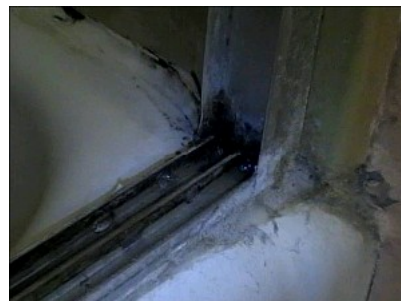
There were signs of microbial growth observed. This is a moderate to serious issue. Suspected microbial growth and its toxicity can only be confirmed by sampling and laboratory testing. Sampling can include tape, swab, air, or bulk methods. The method of remediation depends upon the type of mold. Recommend a mold remediation plan to address clean-up and prevention.

There were signs of water damage observed. This is a moderate to serious issue. Water intrusion into the walls can lead to mold growth and other problems. Removing water-damaged materials for repair or replacement may reveal further damage and microbial growth. Recommend maintenance by a licensed contractor.

There were cracks/open penetrations observed. This is a maintenance issue. Penetrations that allow water to collect or enter the structure create conditions where mold can grow. Water damage or microbial growth occurring as a result may not be visible at the point of penetration. Recommend maintenance by a licensed contractor.

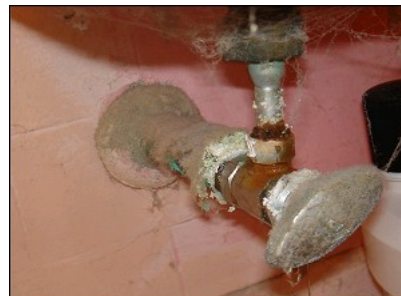
There are signs of corrosion/deterioration. This is a maintenance issue. Corrosion on pipes may indicate a potential water leak that could occur at any time. Water leaks can cause significant damage and create conditions where mold can thrive. Recommend maintenance by a licensed contractor.

Upstairs bathroom toilet supply line.

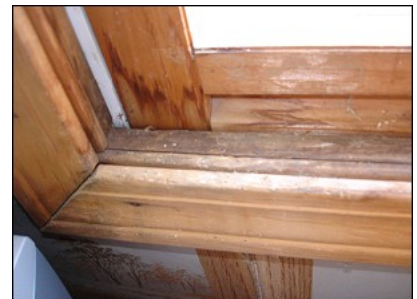
There were signs of water damage observed. This is a moderate to serious issue. Water intrusion into the structure can lead to mold growth and other problems. Removing water-damaged materials for repair or replacement may reveal further damage and microbial growth. Recommend maintenance by a licensed contractor.

There were signs of deterioration observed. This is a maintenance issue. Deteriorated materials may allow water to collect or enter the structure create conditions where mold can grow. Water damage or microbial growth

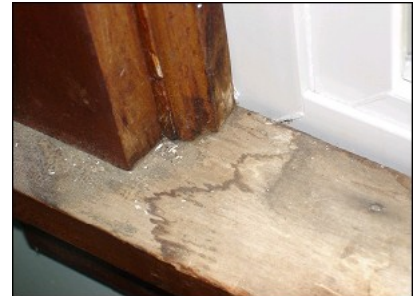
There were signs of water damage observed. This is a moderate to serious issue. Water intrusion into the structure can lead to mold growth and other problems. Removing water-damaged materials for repair or replacement may reveal further damage and microbial growth. Recommend maintenance by a licensed contractor.

Water has penetrated and damaged interior wood window frame

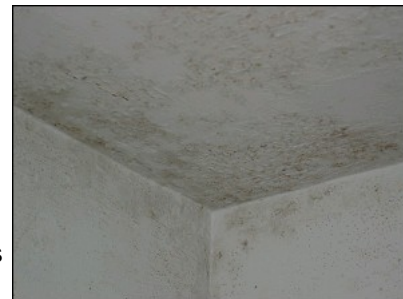
There were signs of microbial growth observed. This is a moderate to serious issue. Suspected microbial growth and its toxicity can only be confirmed by sampling and laboratory testing. Sampling can include tape, swab, air, or bulk methods. The method of remediation depends upon the type of mold. Recommend a mold remediation plan to address clean-up and prevention.

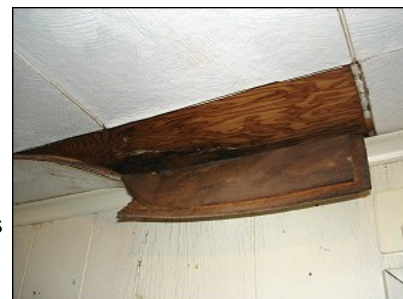
Location: Upstairs north

There were signs of microbial growth observed. This is a moderate to serious issue. Suspected microbial growth and its toxicity can only be confirmed by sampling and laboratory testing. Sampling can include tape, swab, air, or bulk methods. The method of remediation depends upon the type of mold. Recommend a mold remediation plan to address clean-up and prevention.

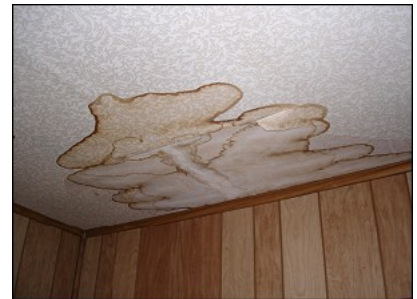
There were water stains observed. This is a maintenance issue. Water stains indicate past water intrusion in this area, which can lead to microbial growth. Recommend maintenance by a licensed contractor.

Ceiling near window. Does not appear to be an active leak.

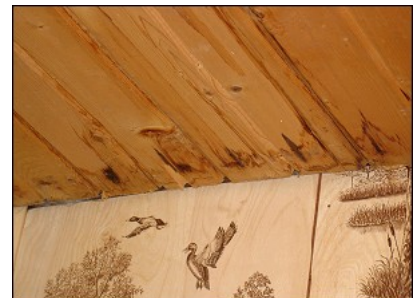
There were water stains observed. This is a maintenance issue. Water stains indicate past water intrusion in this area, which can lead to microbial growth. Recommend maintenance by a licensed contractor.

Ceiling on north side is affected.

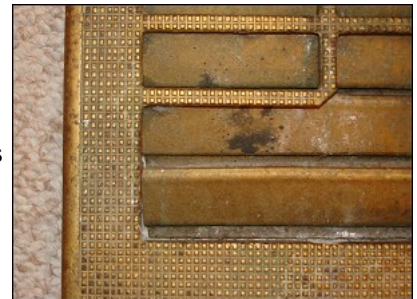
There were signs of microbial growth observed. This is a moderate to serious issue. Suspected microbial growth and its toxicity can only be confirmed by sampling and laboratory testing. Sampling can include tape, swab, air, or bulk methods. The method of remediation depends upon the type of mold. Recommend a mold remediation plan to address clean-up and prevention.

Upstairs bathroom, suspected mold-like substance on vent grid. Client accepted sampling. Recommend a cleaning schedule for vents and ducts. Annual cleaning of vents and ducts by professionals can improve air quality in your home.
